# **The Effects of Manufacturing on the Structural Integrity of Gr/PEEK Composite Parts**

MASTER OF SCIENCE  
IN  
AERONAUTICS AND ASTRONAUTICS

MASSACHUSETTS INSTITUTE OF TECHNOLOGY

September 1990

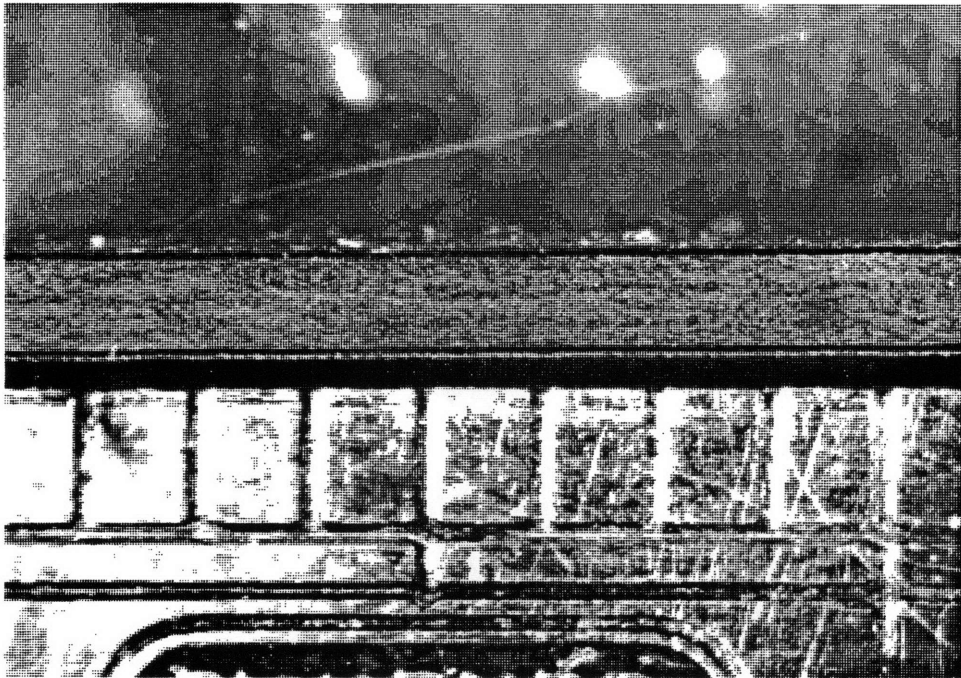
**Figure G1** Picture of a typical edge (P100/0/0-1) of the small plate specimens. The thickness of the specimen is 1.43 mm (.056 in) and the ruler increments are 1.59 mm (.063 in).
